QUARTERLY SITE INSPECTION REPORT

FEBRUARY 1998

**BAILEY SUPERFUND SITE
ORANGE COUNTY, TEXAS**

PARSONS ENGINEERING SCIENCE, INC.

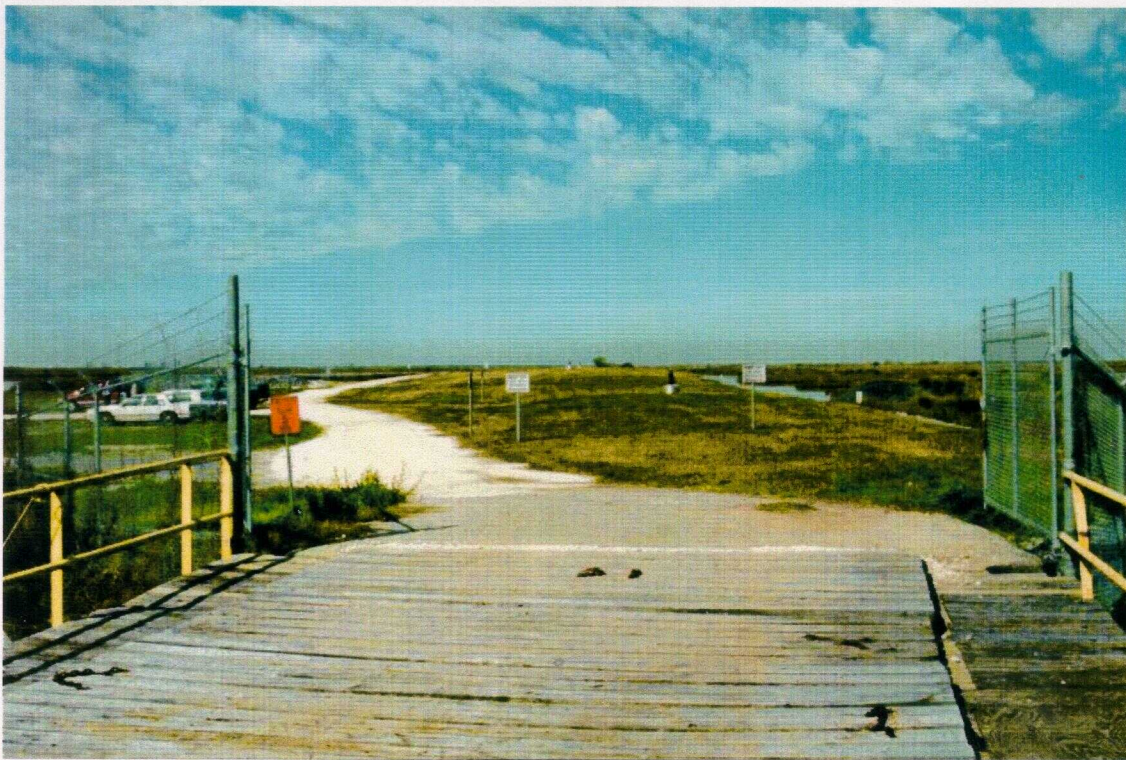
Site Entrance and
Access Bridge.

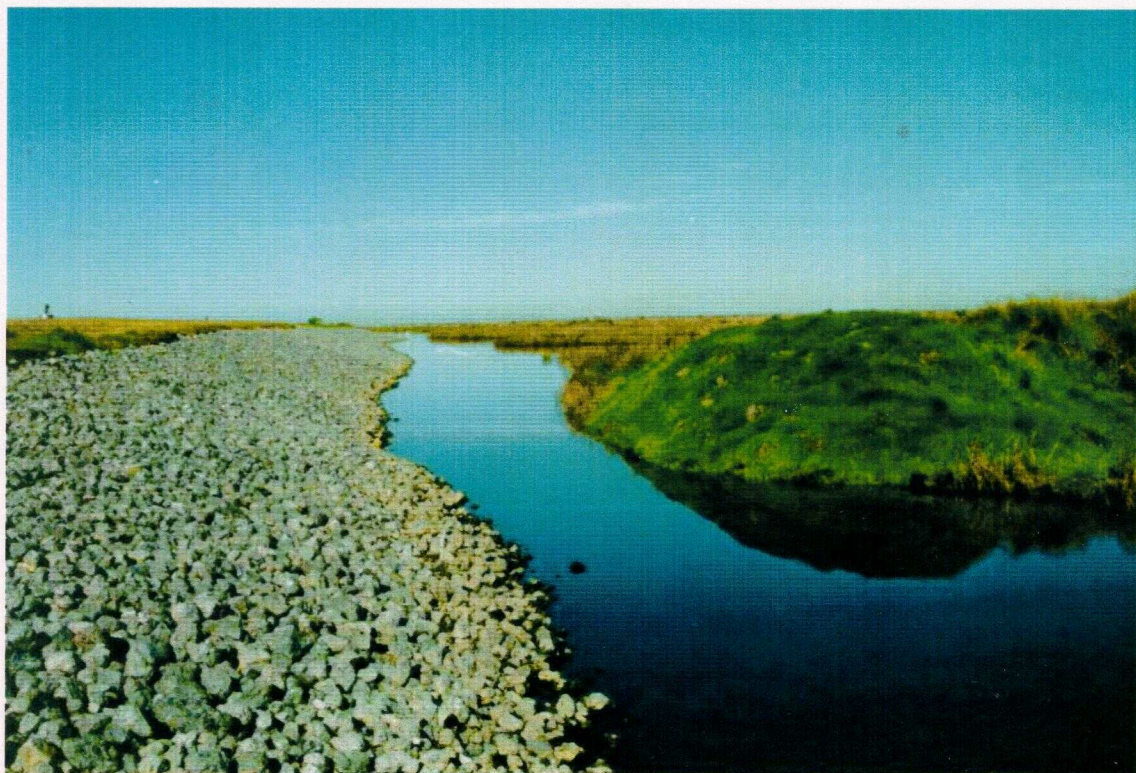
The two breaches in the North Marsh perimeter dike were inspected and found to be in good condition and allowing free flow of tidal waters. Vegetation has started growing on the slope of the breach located in the North Marsh. The drainage pipes in the former laydown area and at the end of the East Dike were found to be in good condition with no obstructions.

Perimeter Dike at
the North Marsh
Breach and North
Dike Slope.

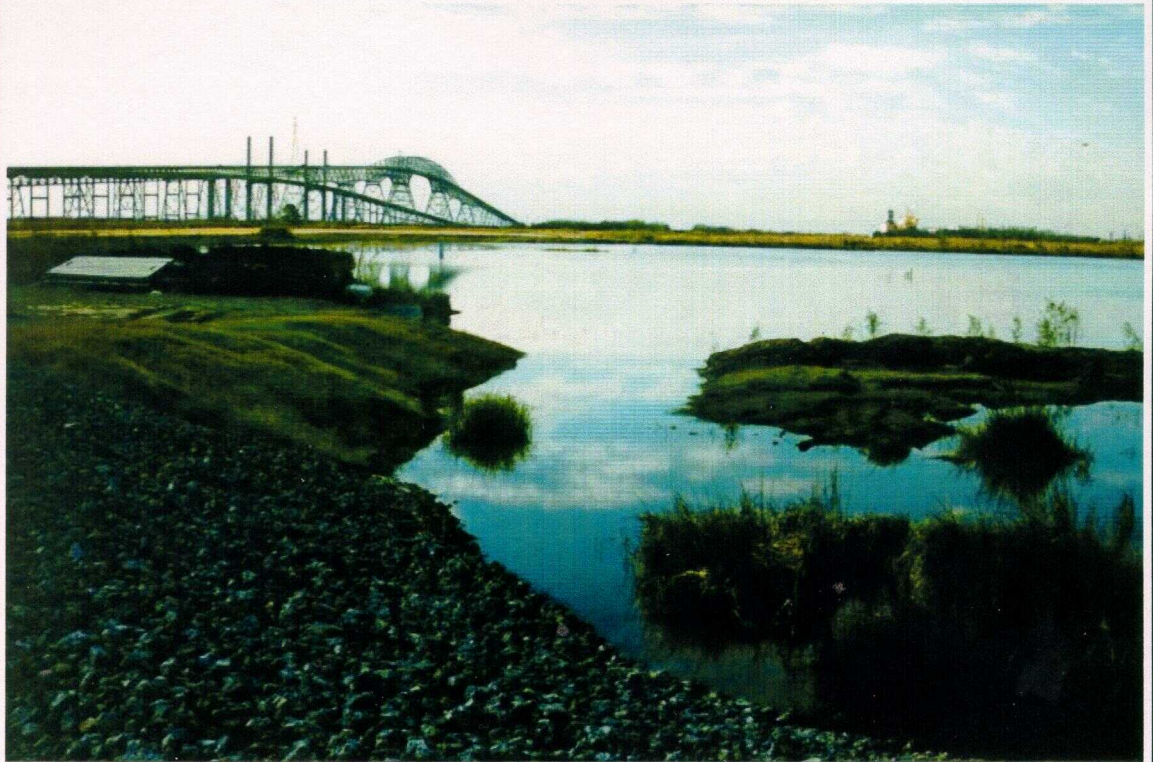
Perimeter Dike at
the Pond A
Breach.

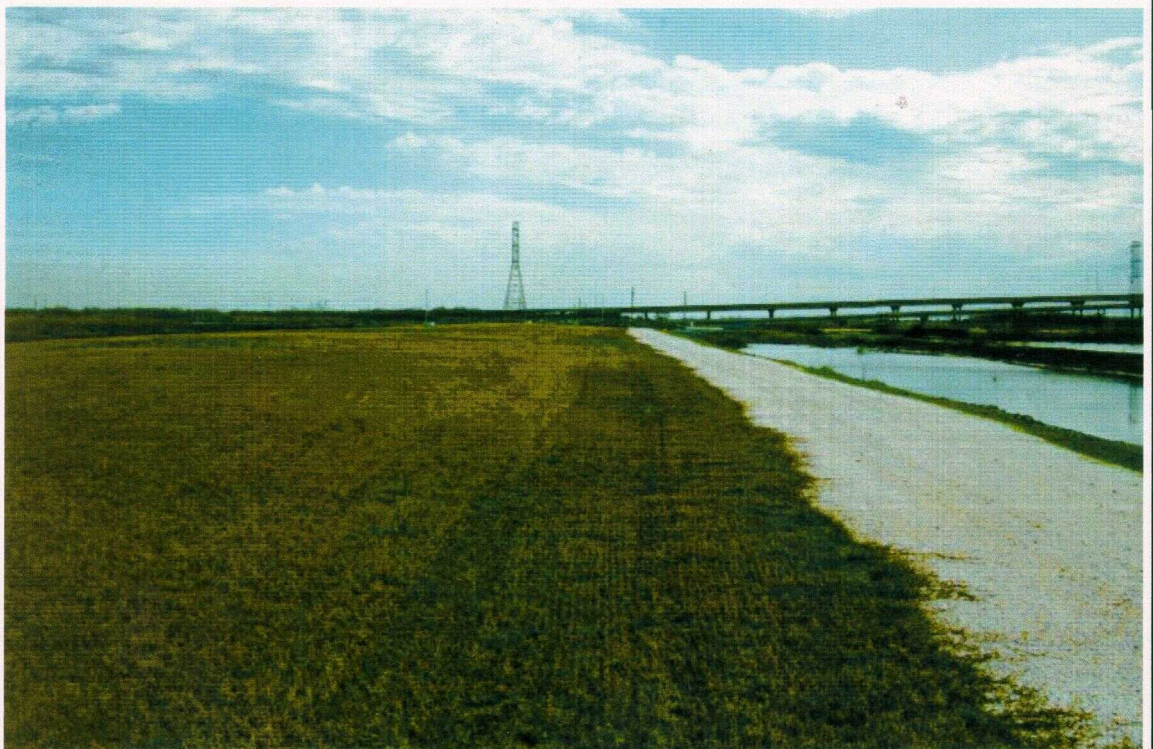
North Dike Cap
and Access Road.

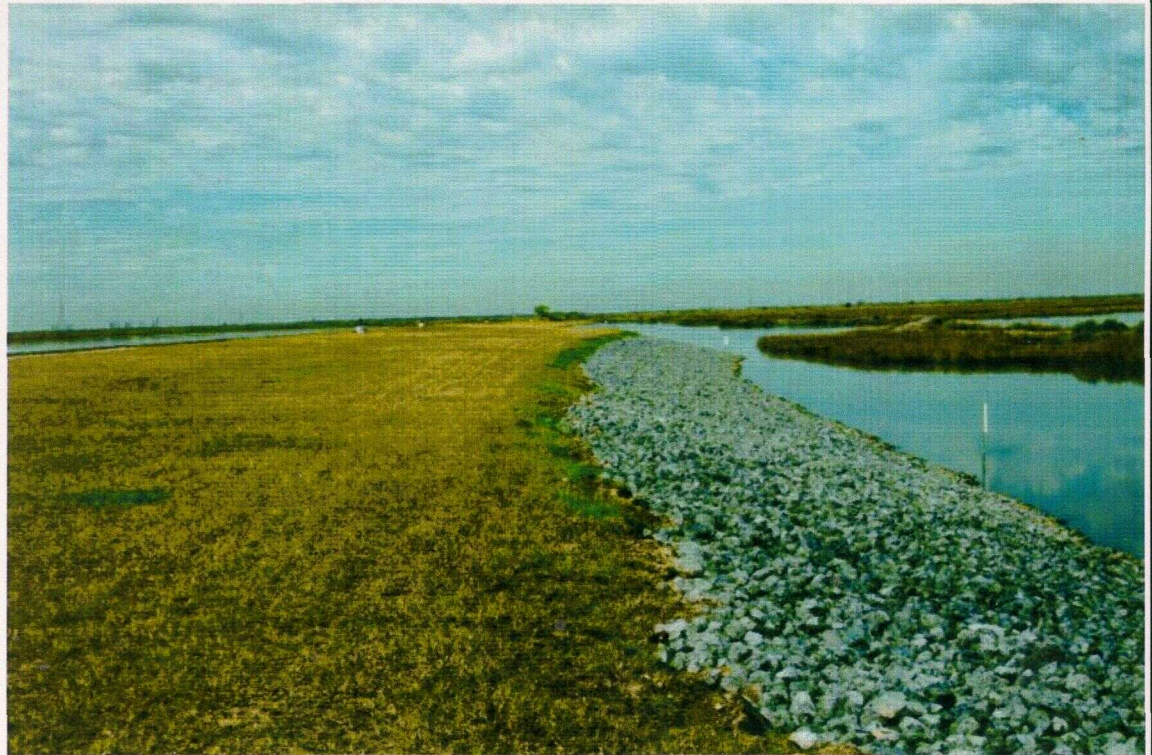
North Dike Cap
and Slopes Along
North Marsh.

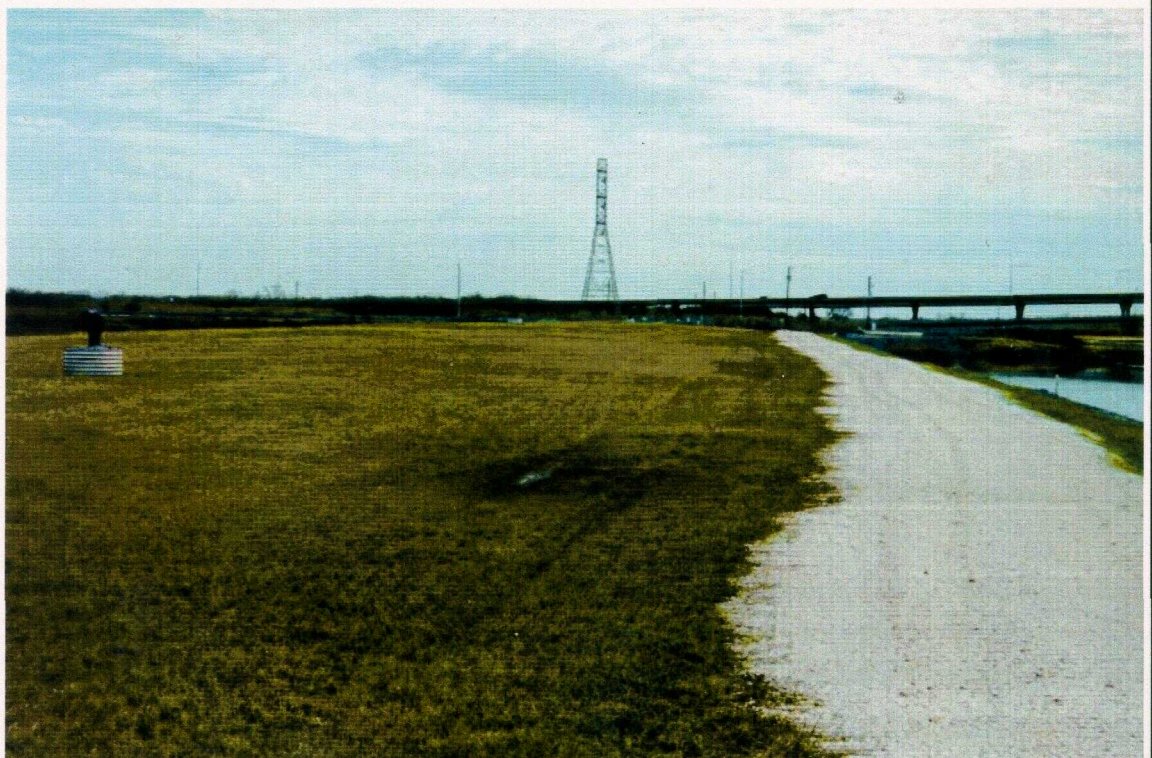
The North and East Dike areas were carefully observed for signs of differential settlement. Some ponding generally less than 2 inches in depth was noted along the edge of the access road of the East and North Dikes. One area located on the East Dike was noted to be approximately 2 to 3 inches in depth. The ponding is believed to be attributed to the saturated soil conditions from the abnormal to date precipitation and the recent heavy rainfall that occurred prior to the inspection. The ponding was very similar to the ponding that was observed during the last quarterly inspection. No evidence, such as distressed vegetation, indicated that this area was not draining properly. The ponding locations are noted on the map provided in Appendix B. One visual observation of possible differential settlement was noted on the North Dike area. This location was on the rip-rap at the western end of the North Dike on the Pond A bank, which is outside of the lightweight geosynthetic composite cap limits. A section of approximately 20 LF in

North Dike Cap
and Access Road;
Isolated Ponding
(<2 " Depth).

2. Some ponding water was observed along the access roads of the North and East Dikes. The ponding is attributed to saturated soils with recent heavy rainfall and a relative flat slope along the edge of the road.	A recommendation is made to mark these areas and fill in with protective soil and grade to provide positive drainage across the cap limits. These areas will then have to be fertilized and seeded.

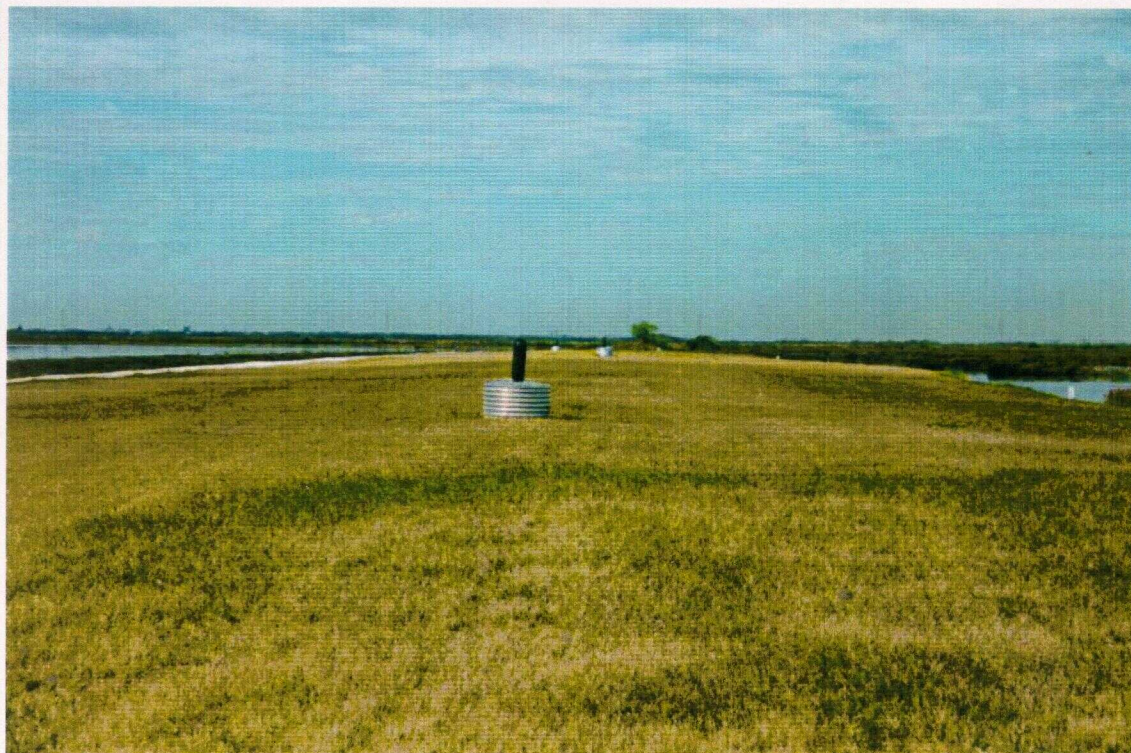
North Dike Cap
along Ridge Line
and Gas Vent.

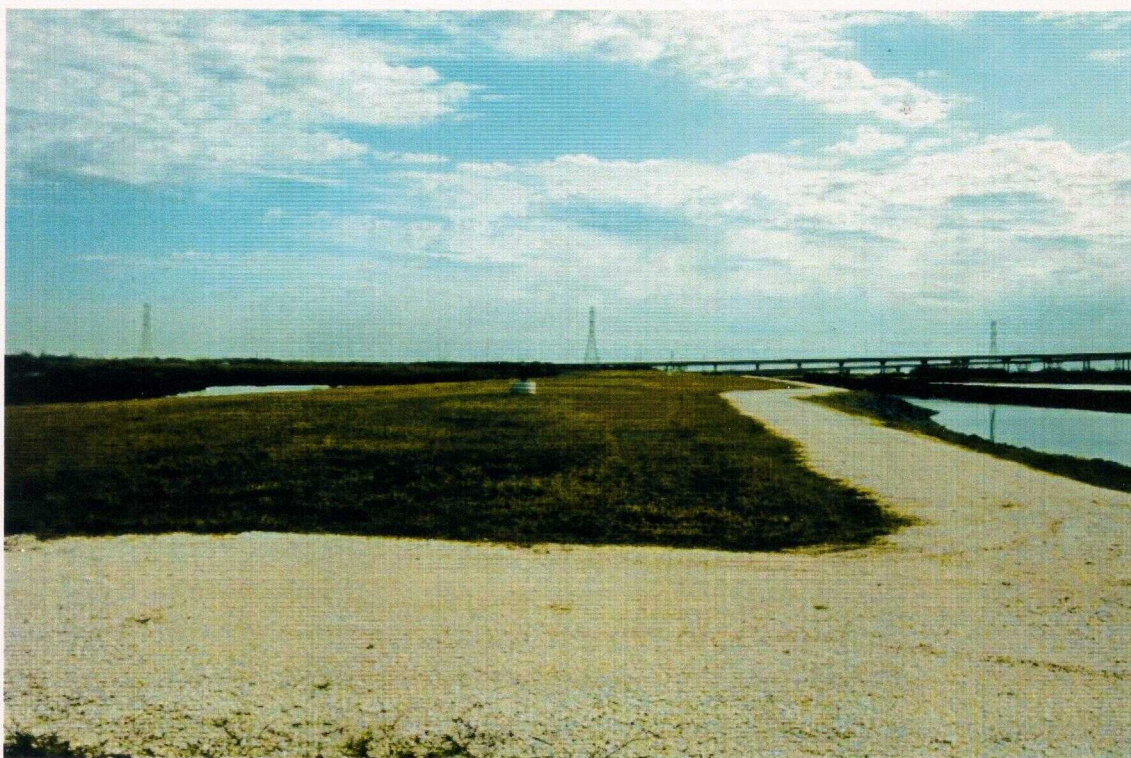
North Dike Cap
and Access Road
Turnaround.

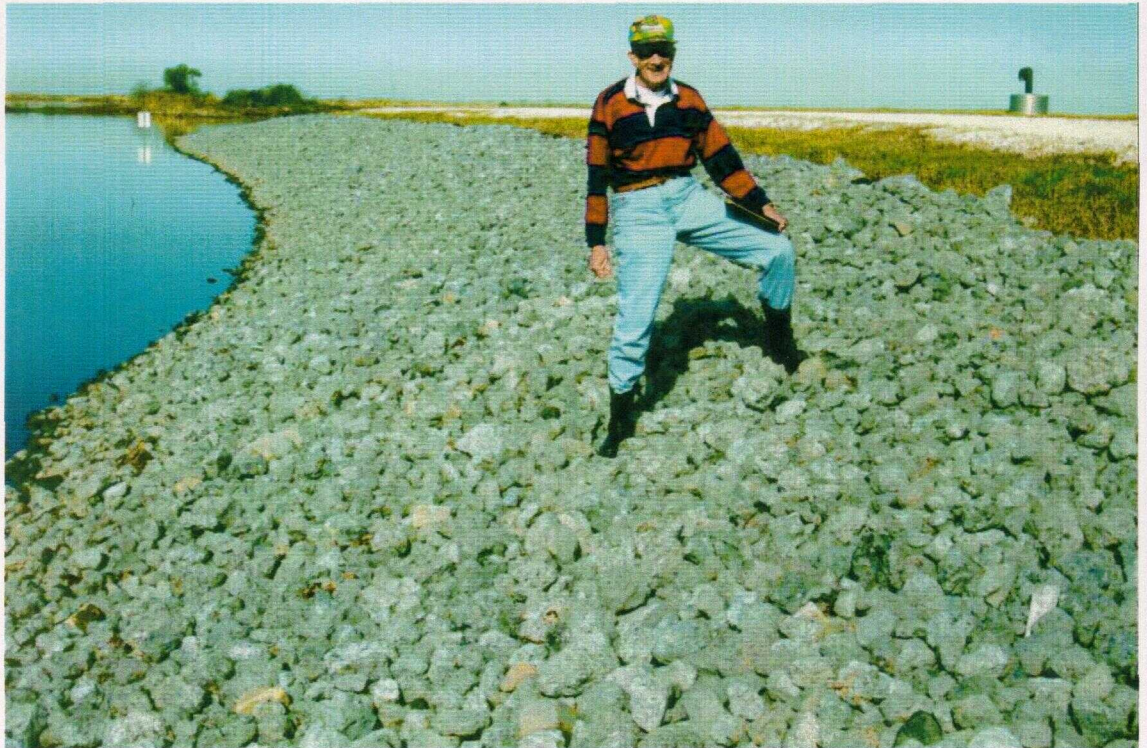
length appears to have a dip of approximately 1 foot or less in the middle of the slope from adjacent areas. This location was noted on the map provided in Appendix B. This is the same location that was observed during the last Quarterly Inspection conducted on November 21, 1997. Little change appears to have taken place since the last inspection. No cracking was observed in the immediate area or any other signs of distress to the nearby cap areas.

North Dike Slope
along Pond A;
Possible Minor
Settlement
Location.

6. Possible differential settlement was observed in a small area of the rip-rap slope located outside of the geosynthetic lightweight cap limits on the North Dike. No signs of differential settlement were observed on the adjacent cap areas. This location was noted on the map included in Appendix B.	The recommended action is to continue visual monitoring of this area.

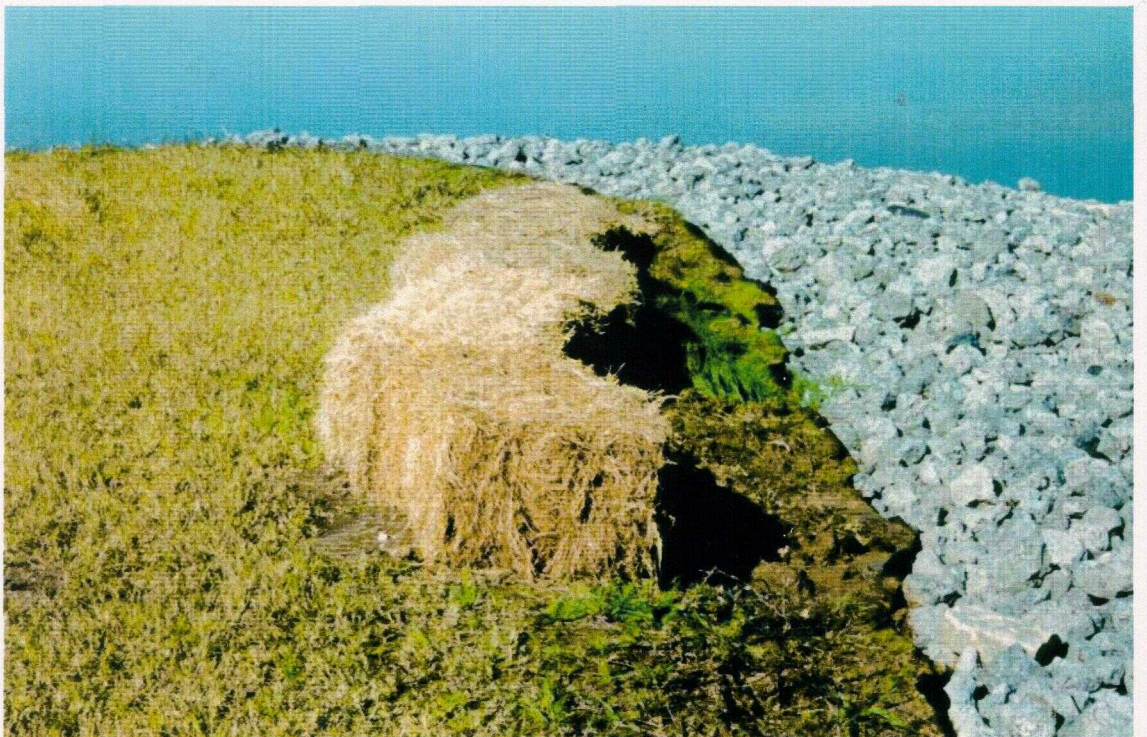
The areas of the geosynthetic lightweight cap were inspected for signs of erosion. No signs of significant erosion were observed. The location on the North Dike (west end) previously identified during the last inspection had been repaired and appears to be in good condition. The hay bales are providing erosion protection while the grass is developing. Other areas where erosion channeling had been repaired are holding up well and winter grass is developing. No exposed geosynthetics were observed.

North Dike Cap;
Hay Bale Erosion
Control at
Repaired Location.

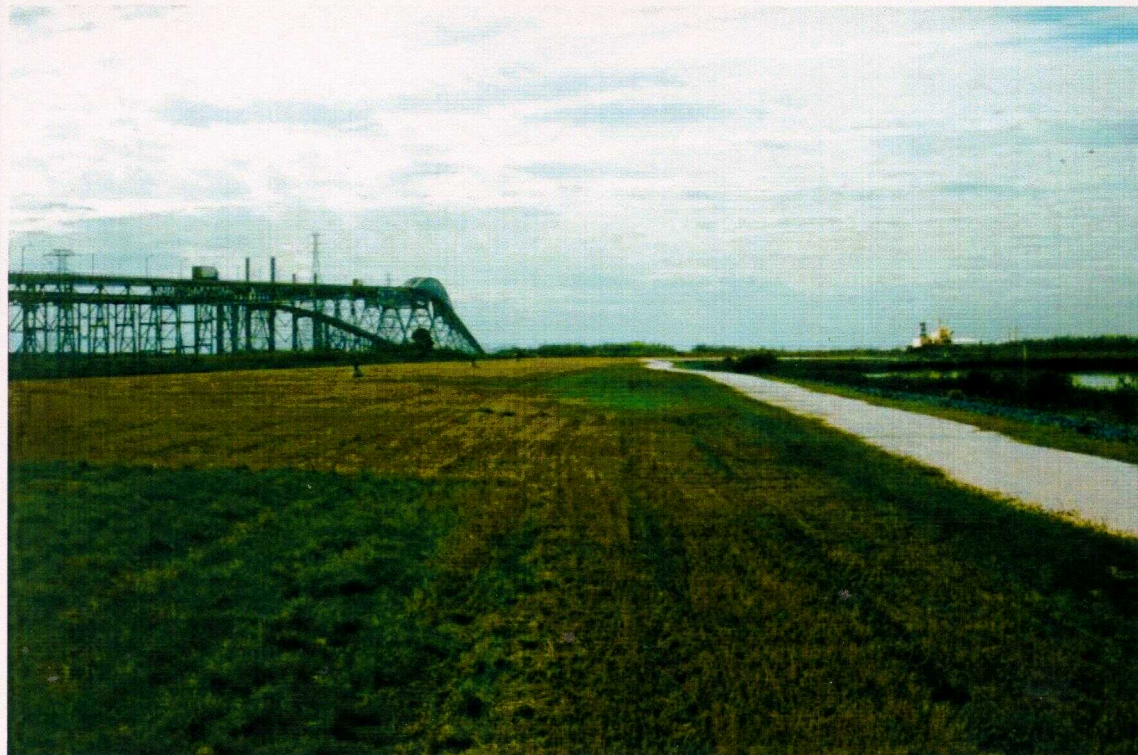
East Dike Cap and
Access Road.

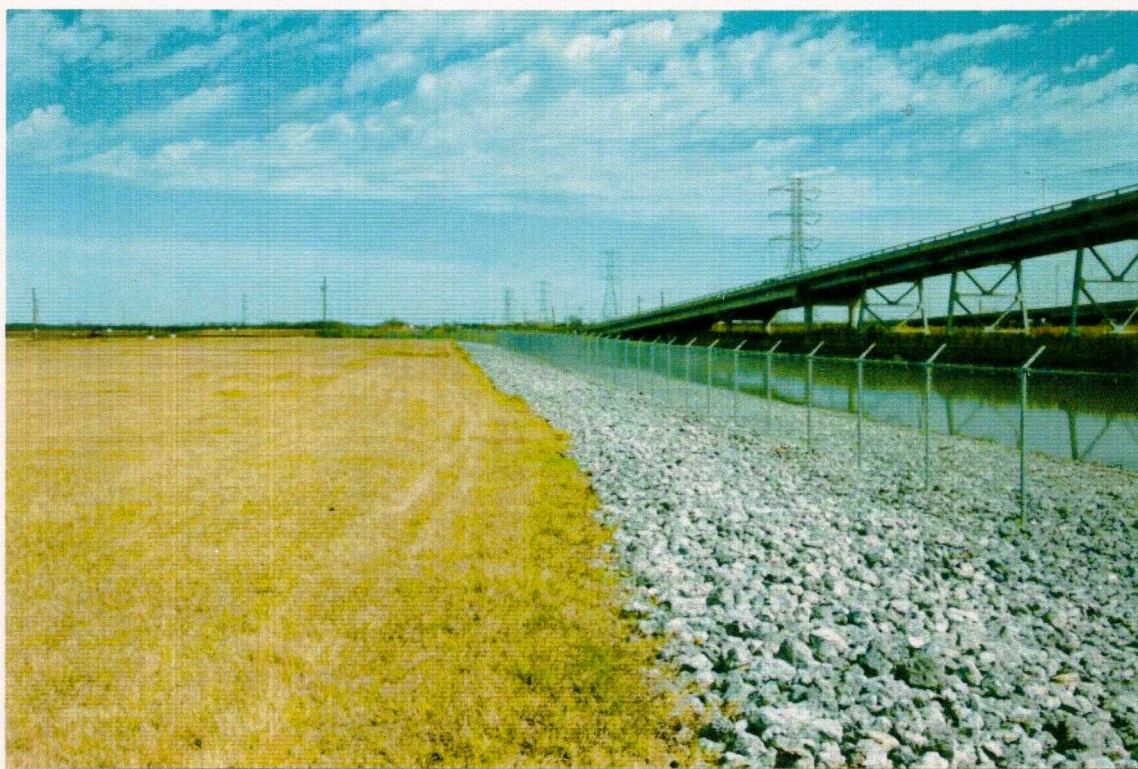
East Dike Cap,
Slope, and Fence
Along the East
Drainage Channel.

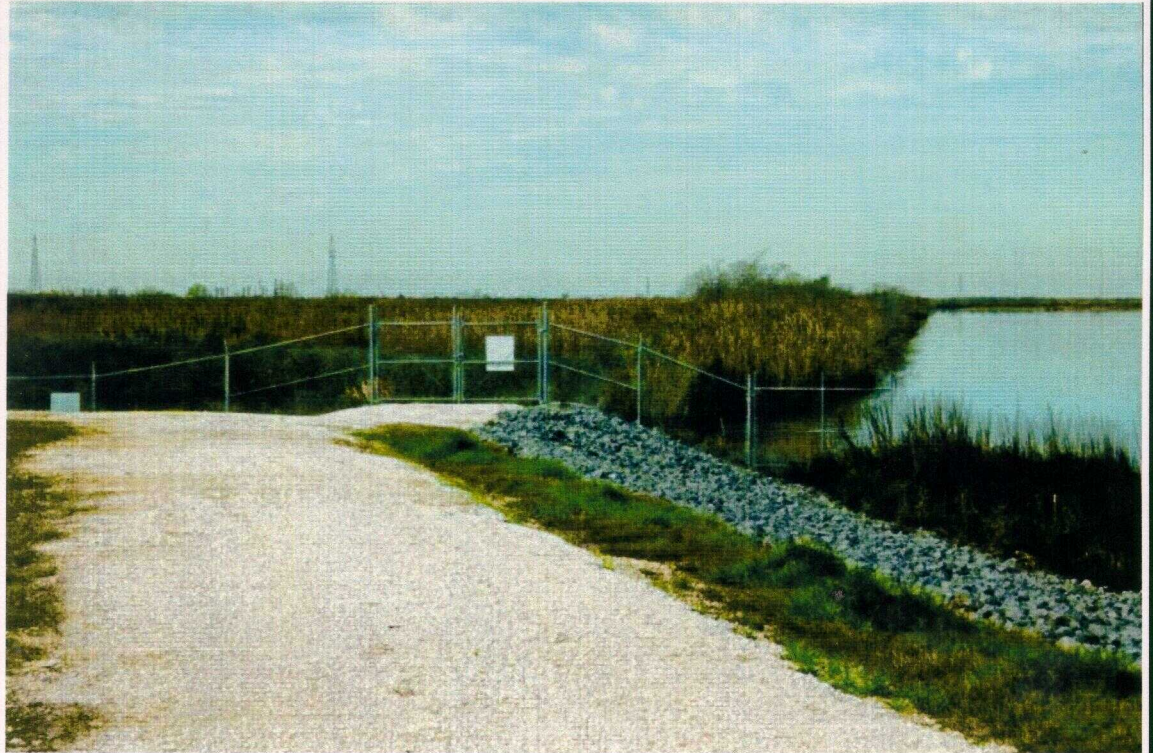
East Dike Access
Road, Fence, and
Gate.

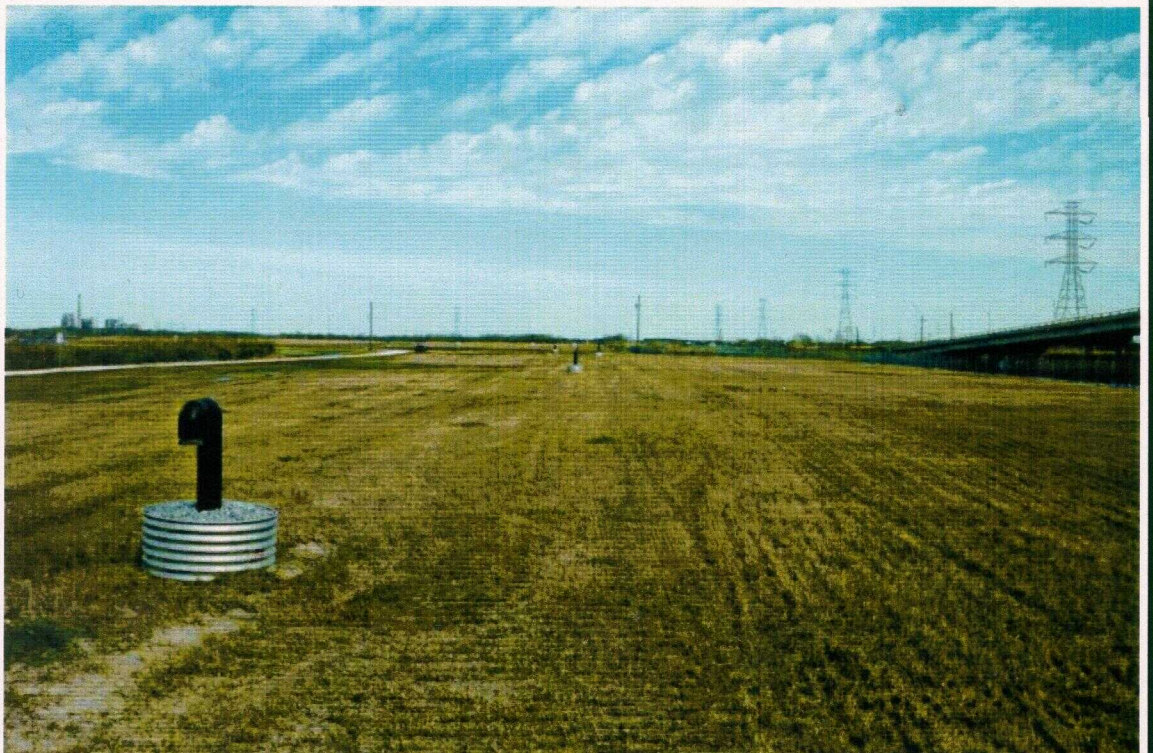
East Dike Cap
Along Ridge Line
and Gas Vent.

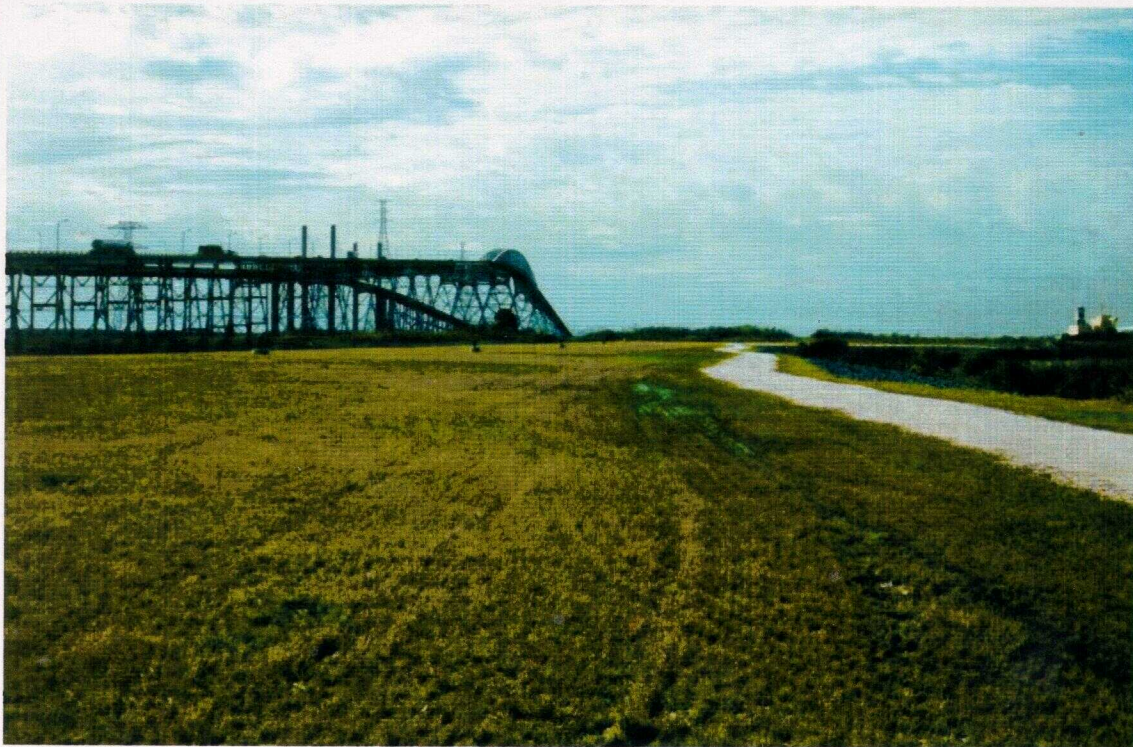
East Dike Cap and
Access Road;
Isolated Ponding
Area (<2" Depth).

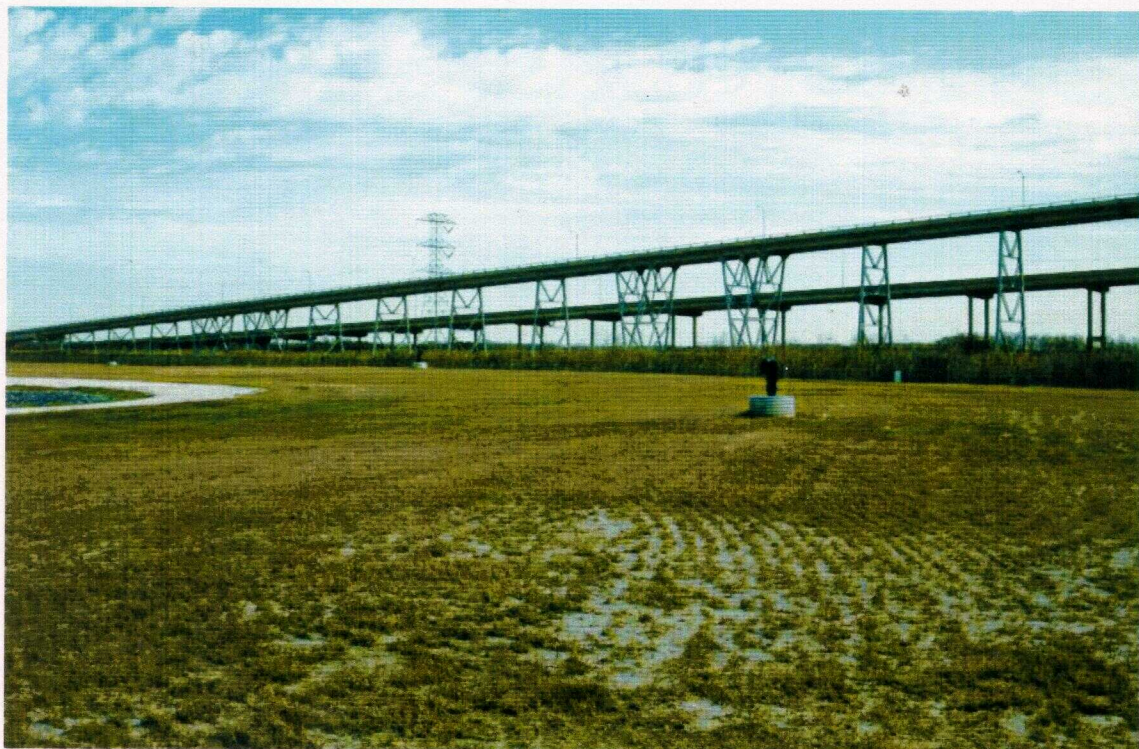
East Dike Cap and
Gas Vent at
Southern End.

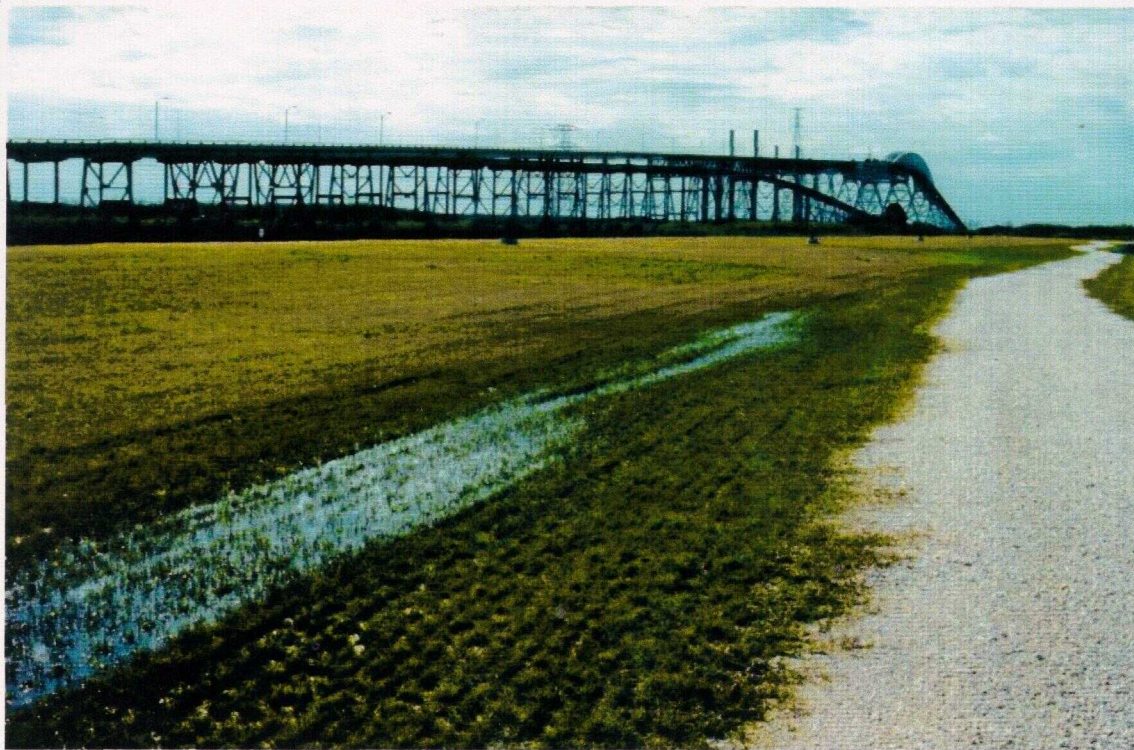
East Dike Cap;
Ponding Area (<2"
Depth).

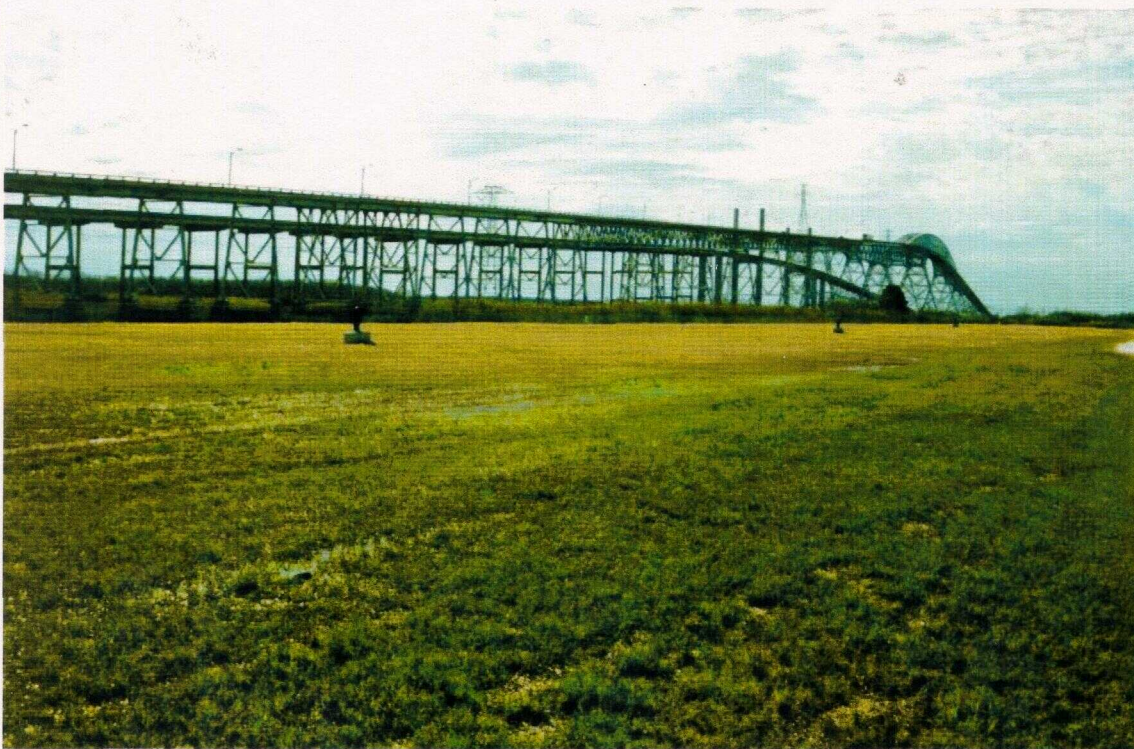
East Dike Cap;
Ponding Area (2"
to 3" Depth).

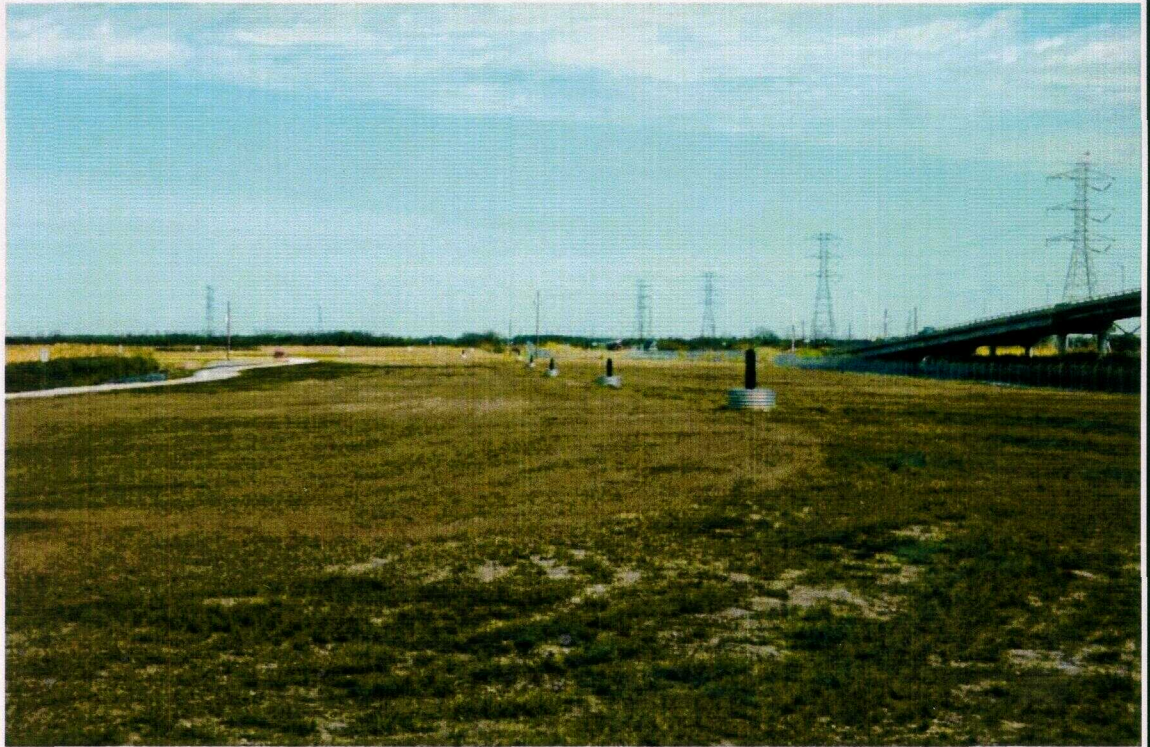
East Dike Cap and
Gas Vents Along
Ridge Line.
